AUTOWASH

PHOTOS CAPTURED CARRYING OUT RISK ASSESSMENT Ref: 738/01/300409 FOR ZIP CARS
AT FINSBURY SQUARE, NCP CAR PARK, LONDON, EC2A 1AD

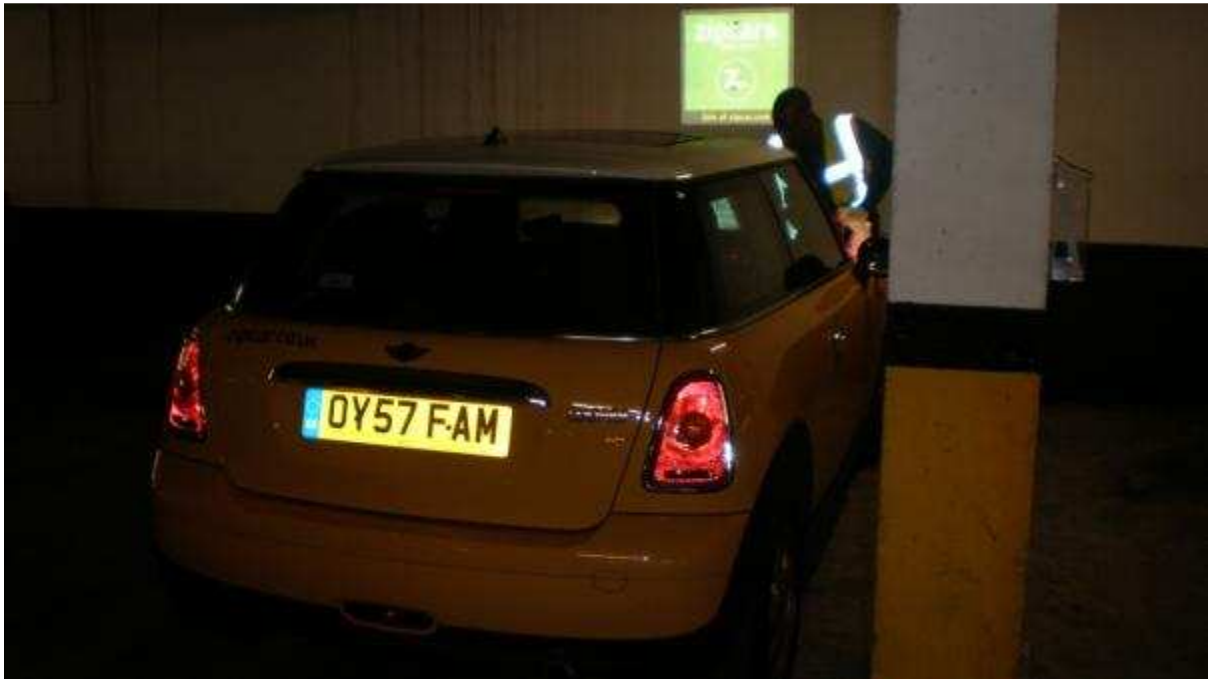
Photo Ref: 001 Hazard No: 10 Photo of the vehicle being validated.

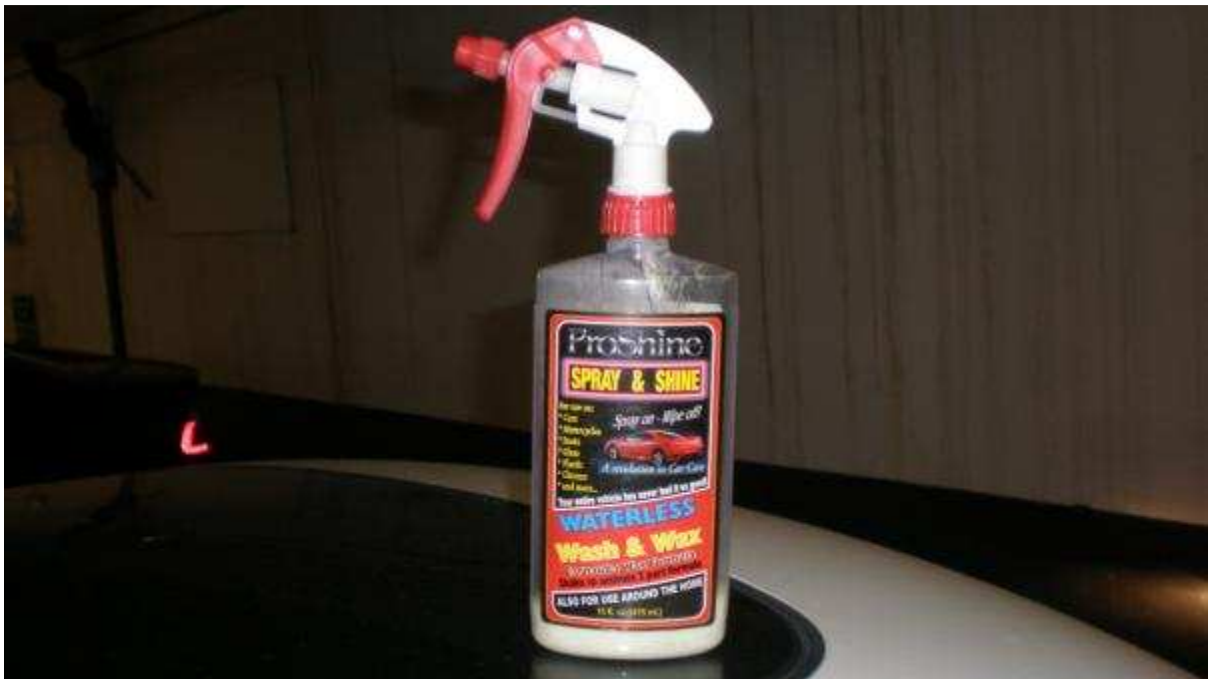
Photo Ref: 002 Hazard No: 04 Hazardous substances are decanted to smaller quantity.

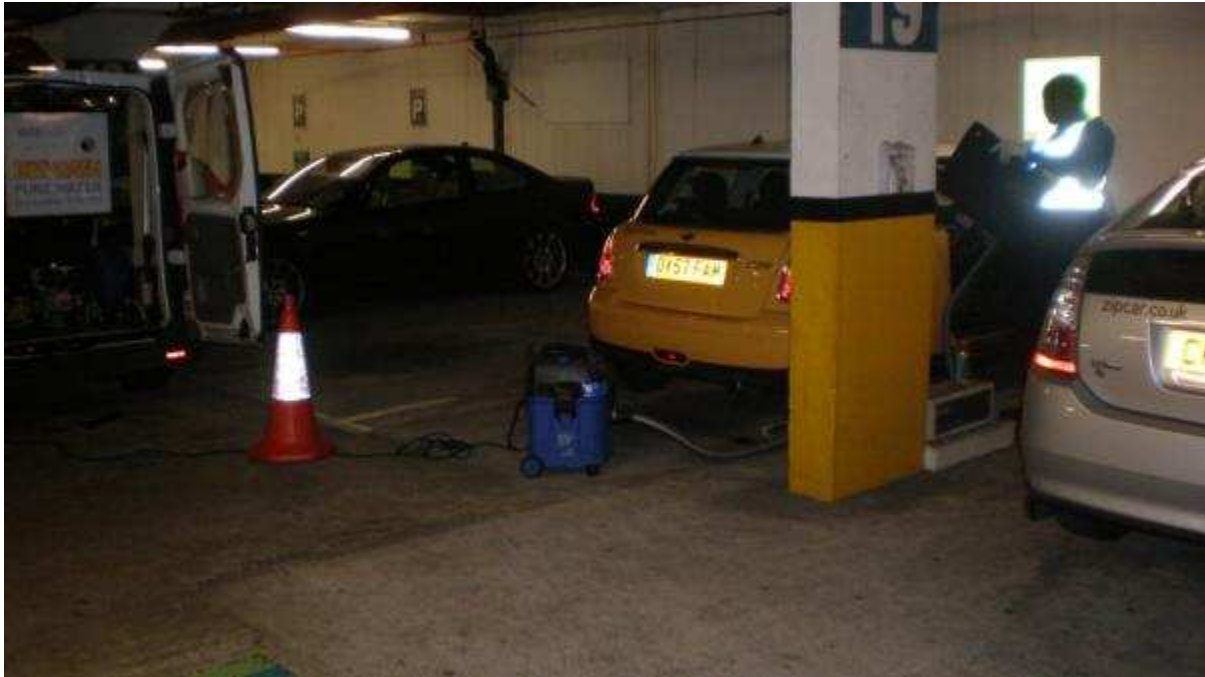
Photo Ref: 006 Hazard No: 02 Work equipment is maintained and in good working order.

Hazard No: 03 Electric cable from vehicle to vacuum is to be covered with cable protector to reduce the probability of work accidents. Currently a cone is used which leaves portion of the cable exposed.
